JAMES WEBB SPACE TELESCOPE (JWST) INTEGRATED SCIENCE INSTRUMENTS MODULE (ISIM) CRYO-VACUUM (CV) TEST CAMPAIGN SUMMARY

¹NASA Goddard Space Flight Center

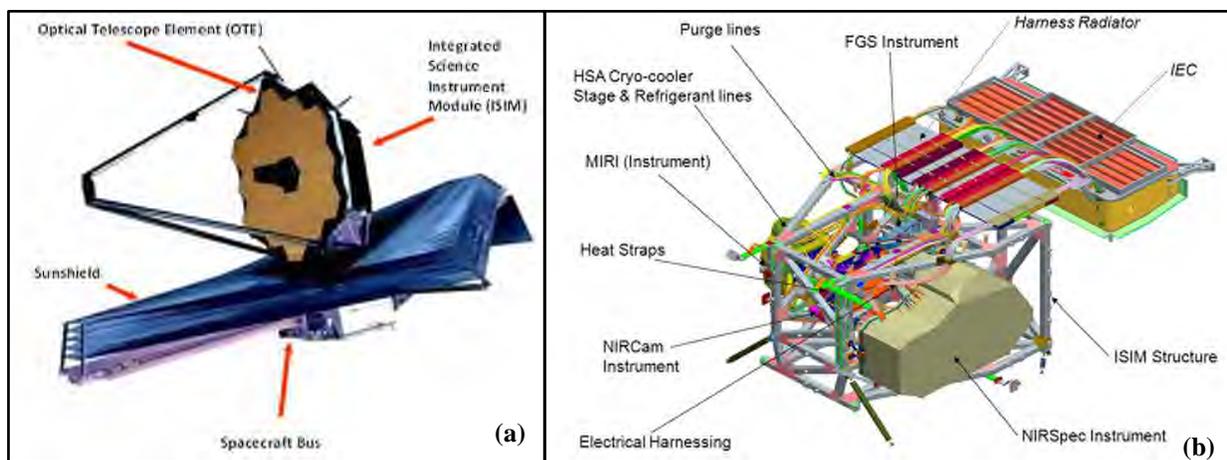
Figure 1 (a) Diagram of the entire JWST observatory (b) ISIM elements

The James Webb Space Telescope (JWST) is a multi-billion dollar space-based telescope (Figure 1a) aimed to enable insights into the formation of galaxies and planets after the “Big Bang.” The objective will be achieved using four science instruments (SI) that operate in short to medium wavelengths: Mid-InfraRed Instrument (MIRI), Fine Guidance Sensor (FGS), Near-InfraRed Spectrometer (NIRSpec), and Near-InfraRed Camera (NIRCam). The composite structure housing the SIs, shown in Figure 1b, is called the Integrated Science Instruments Module (ISIM).

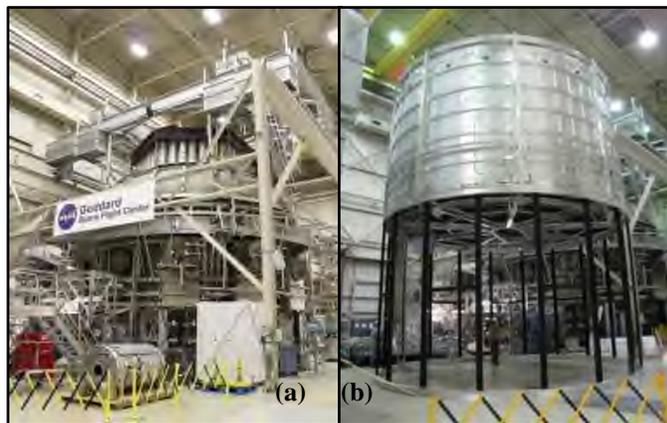
Figure 2 (a) GSFC SES Chamber (b) Helium Shroud

The Space Environment Simulator (SES) chamber shown in Figure 2, Facility 290, at NASA GSFC underwent several modifications in order to provide a platform by which the thermal specifications required of the JWST ISIM CV testing program could be successfully achieved. In 2012, the paper *James Webb Space Telescope Integrated Science Instrument Module Cryogenic Vacuum Test Planning* was presented in the 27th Space Simulation Conference and covers the finer details with a comprehensive overview of the changes and upgrades involved to prepare the SES for ISIM-level testing. Furthermore, in 2014 at the 28th Space Simulation Conference, the paper *James Webb Space Telescope Integrated Science Instrument Module Cryo-Vacuum Testing at GSFC* described the SES modifications since the initial commissioning and the results of the CV1 test. In this paper, therefore, only the high-level SES facility capabilities are listed below. The remaining part of this chamber overview section documents the changes (if any) of supporting instrumentation for the three CV tests.

- Internal volume: 27' diameter x 40' high
- Payload support weight: 26,000 lbs
- Temperature: 83K to 348K (-190°C to +75°C)
- Vacuum pressure: 10⁻⁷ Torr
- Hardware access: 6' high x 5' wide personnel access door; 15 ton crane capacity for hardware loading through the top dome of the chamber
- A 1.0 kW (at 20K) helium refrigeration system with 10-zones (one supply and ten individually valved return line) for gaseous He circulation

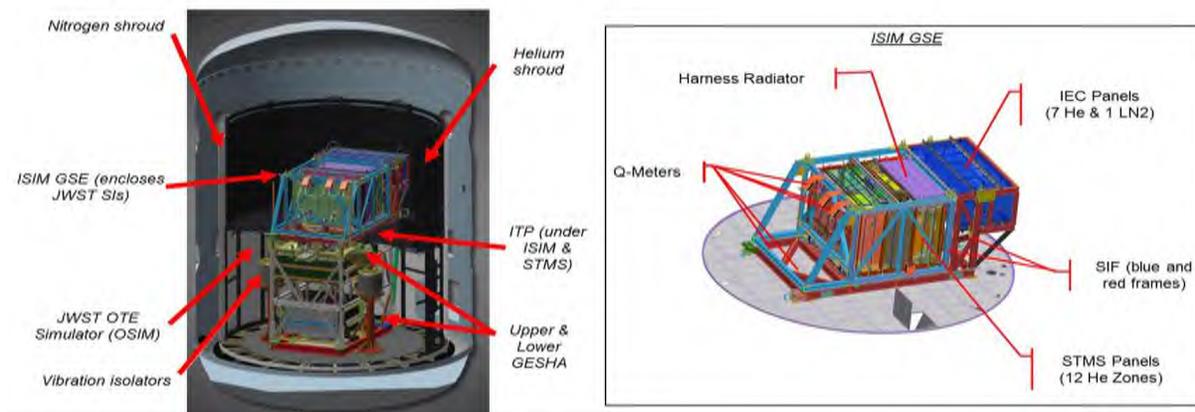
Figure 3. Configuration of ISIM and ground support equipment (GSE) for CV tests

Figures 3 & 4 depict the JWST ISIM full configuration within the SES using required facility and GSE capabilities. Refer to the 2014 conference paper for descriptions of the GSE shown in Figure 3.

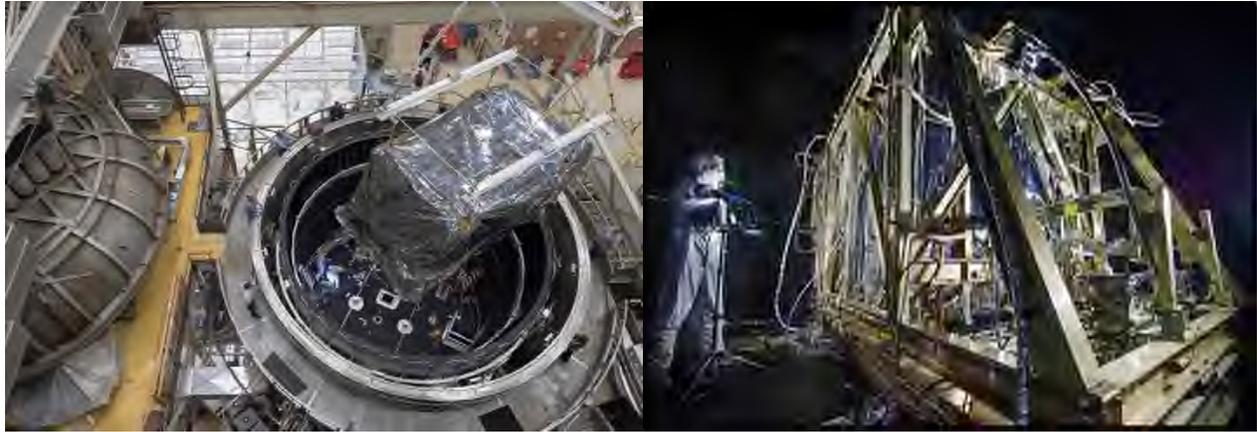
Figure 4. Actual configuration (a) Successful lift of ISIM element into SES for CV3 test; (b) ISIM element inside helium shroud for CV1 test

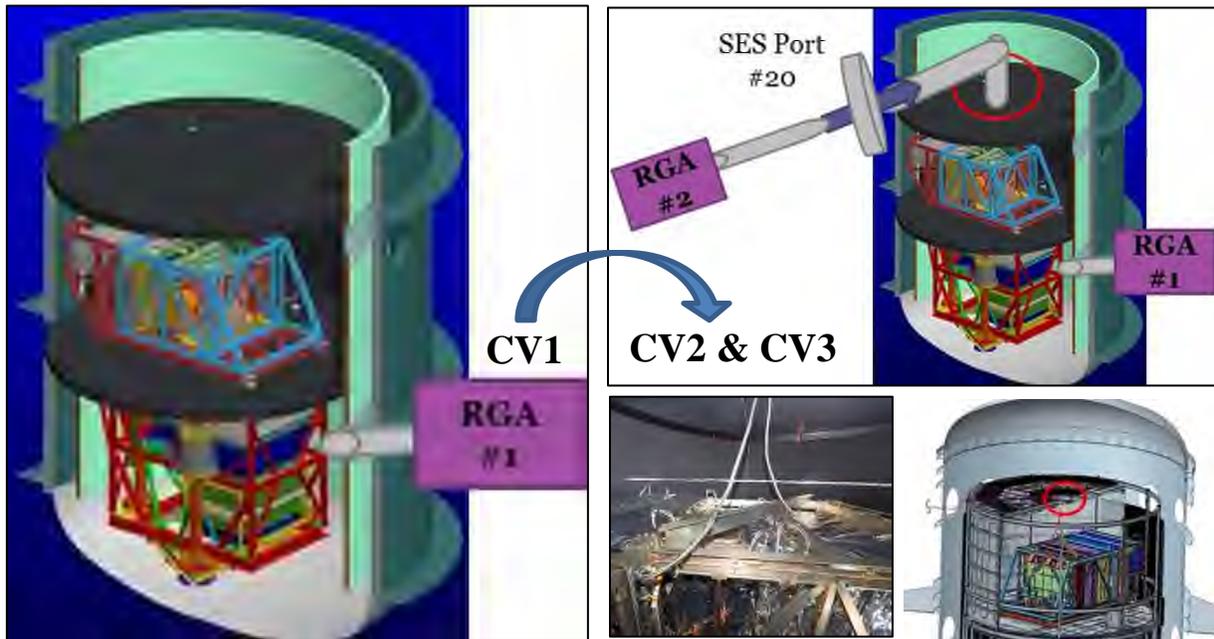
Figure 5. Evolution of RGA configuration and upgrades during CV testing

The most notable improvement attempts made for the additional support instrumentation implemented between the three JWST ISIM CV tests were those related to the RGAs and micro IGs. The motivation for upgrading RGA capabilities was to meet critical verification requirements for the MIRI cooler, the SI instrument with a high sensitivity to any helium levels in the chamber; the details of the MIRI-related verification test requirements and associated RGA analysis and results are detailed in the “Evaluation of Helium Leaks within the Helium Shroud Volume” section of this paper. The motivation for improving the micro IG use was to keep hardware, namely the IEC, and its operations safe. Figure 5 below shows the evolution of RGA changes made in pictorial form; and Figure 6 depicts the micro IG

For CV2, a second RGA was added to the test configuration in an attempt to understand helium background levels in closer proximity to MIRI. Helium sampling for the second RGA was attained by routing a $\frac{1}{2}$ ” flex line from an upper chamber port (Port 20) into the STMS through an opening at the top of the helium shroud. This second, or Port 20 RGA, was mounted outside the chamber (ref. Figure 5) and connected to the vacuum-side flex line at a Port 20 feedthrough.

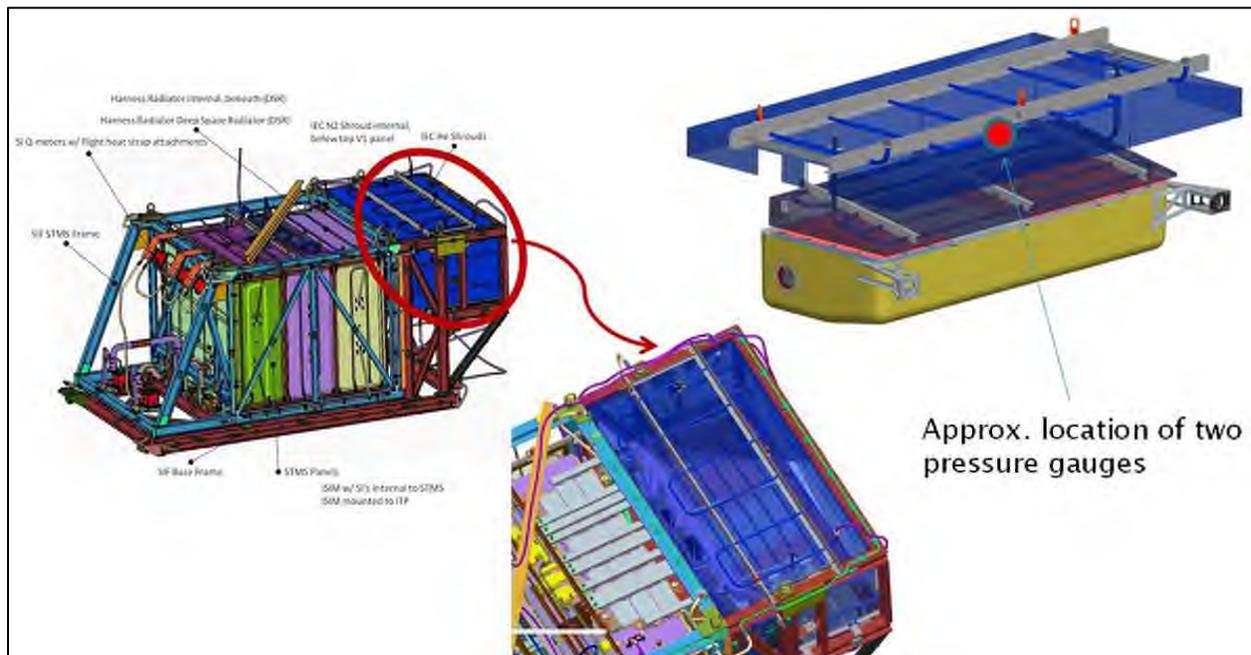
Figure 6. Configuration of IEC micro IGs for CV testing

changes specifically for the IEC volume throughout CV testing. Micro IGs were added into this volume to provide the knowledge necessary to understand the local pressure within a tightly enclosed volume with limited venting, so as to prevent premature activation of cooling loops that could result in ice formation without a high enough vacuum.

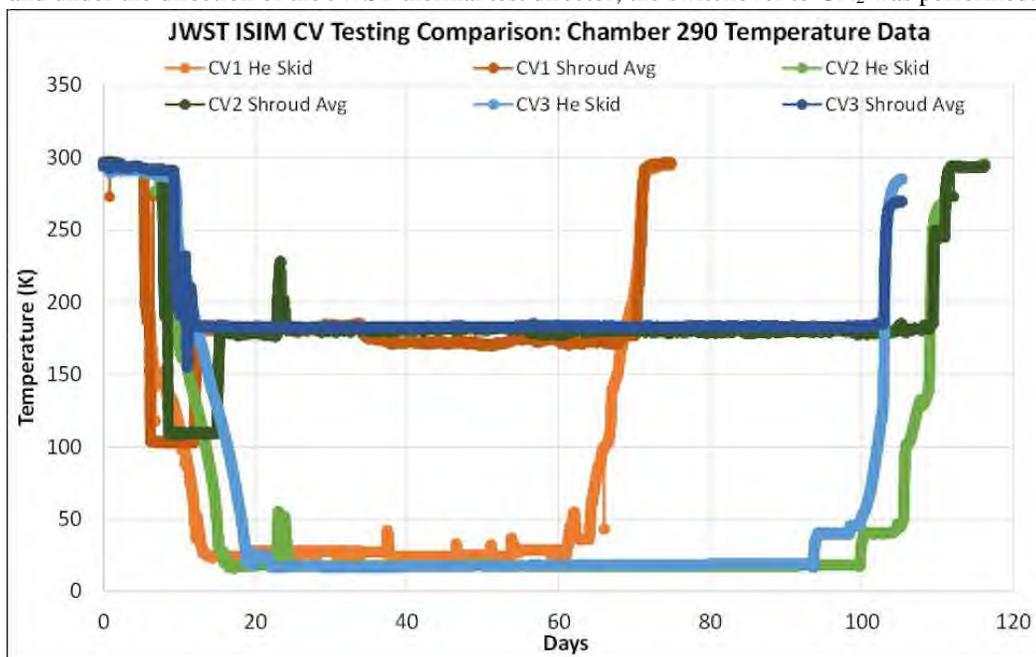
Figure 7. ISIM CV Facility N₂ and He Shroud Temperature Results

The nitrogen and helium shroud systems proved capable of maintaining required nominal operating temperatures. The nitrogen shroud operated at $182\text{K} \pm 4\text{K}$ ($-91^\circ\text{C} \pm 4^\circ\text{C}$) during every test at steady state GN₂ conditions, while the helium shroud achieved $24\text{K} \pm 1\text{K}$ ($-249^\circ\text{C} \pm 1^\circ\text{C}$) for the same test duration (Figure 7). The steady state temperatures reported here neglect the temperature fluctuations that resulted from facility-related issues, such as helium skid compressor shutdowns or power outages that would result in temperature spikes. Despite several efforts to locate a known leak in the nitrogen shroud prior to ISIM testing, these efforts were unsuccessful. As a result, during the steady state portions of the CV test campaign, the nitrogen shroud operated in GN₂ mode, to prevent the cold leak in the shroud to worsen in a flooded LN₂ shroud situation. To facilitate the initial cool-down stage of the test, however, the nitrogen shroud was flooded with LN₂. Upon achieving a helium shroud temperature around 50K (-223°C) and under the direction of the JWST thermal test director, the switchover to GN₂ was performed.

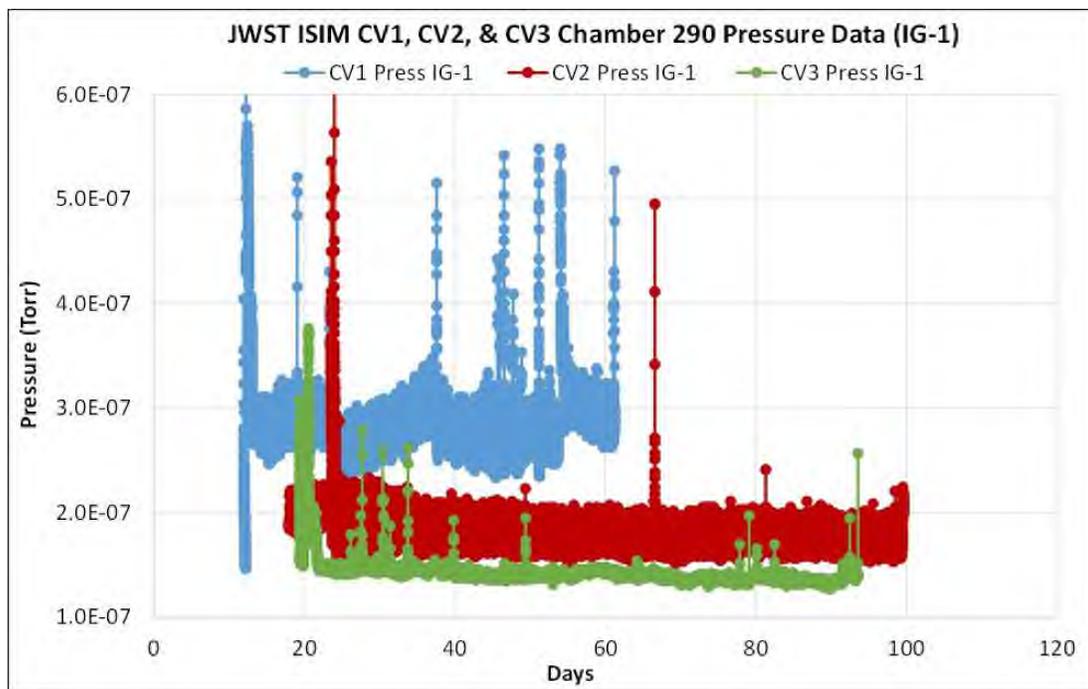
Figure 8. ISIM CV Facility 290 Pressure Results

The SES chamber vacuum system performed exceptionally consistently for the entire CV test campaign, with incremental improvements in vacuum levels with each test (Figure 8). In CV1, the chamber vacuum system successfully held a nominal pressure of 3.0×10^{-7} Torr for the steady state portions of the test. In CV2 and CV3, the facility maintained a nominal pressure of 1.7×10^{-7} Torr and 1.4×10^{-7} Torr, respectively. The standard operating philosophy for maintaining the nominal pressure is to keep 5 of the 7 cryopumps online with the other 2 in reserve. When a cryopump requires regeneration, therefore, an easy swap of cryopumps can be made without fluctuations in the pressure. Deviations from the nominal pressure occurred whenever there was a momentary power outage or a helium skid shutdown. The pressure spikes in these cases result from the sublimation of nitrogen off of the helium shroud due to higher pressures.

The small improvements in vacuum pressure with each CV test can be attributed to a couple of factors. Between CV1 and CV2, JWST implemented more stringent leak checking practices during I&T activities in the cleanroom prior to lifting into the chamber. There were about three dozen flex line connections that needed to be leak-checked prior to the start of the test. In CV1, the requirements for leak-check levels was to evacuate each line to 10^{-8} Torr range, spray helium at the external joints, and ensure same vacuum levels are maintained in each line prior to spraying with helium. For CV2, the standard leak check levels were enforced down to the 10^{-9} Torr range, and the vacuum performance subsequently improved. JWST, therefore, adopted the same leak checking procedures during preparations leading up to CV3. The higher vacuum performance in CV3 may be explained by the fact that the nitrogen shroud failed to flood in LN₂ mode due to facility issues, so the chamber shroud operated in GN₂ for the entire CV3 test duration. Although this slowed down the cool-down rate for the test, it could have increased vacuum performance since it also eliminated the concern of introducing and exasperating the nitrogen shroud leak, which is an effect that is characteristic of going into LN₂ mode.

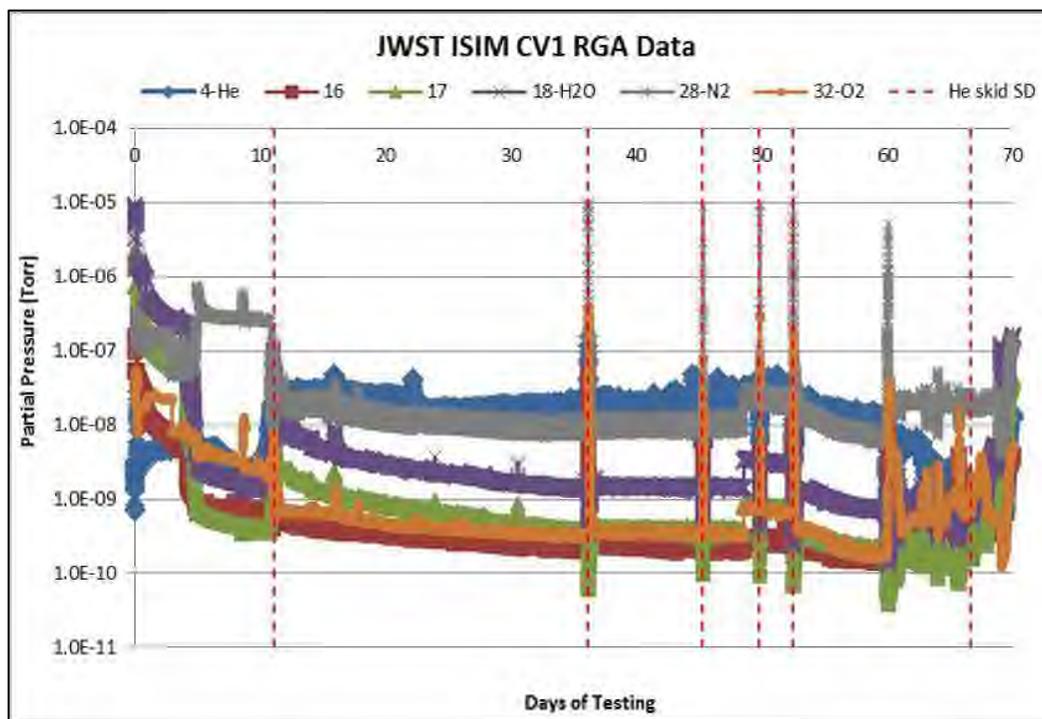
Figure 9. ISIM CV1 chamber RGA data results

At operating temperatures, helium gas would be the presumed medium for any FMHT within the SES. CV1 RGA data (Figure 9) shows partial pressures of helium, at the RGA location along the warm outer chamber wall, at levels approaching 10^{-7} Torr. If this had represented the correct pressures at ISIM, then the FMHT to MIRI would have been in the 0.2 to 2 mW range. However, the two possible sources of helium, the facility helium shrouds and the cryocooler, resided inside the shroud or STMS enclosures. Actual helium pressure is expected to be higher in those volumes than measured at the RGA due to the pumping impedance through small openings in the enclosures.

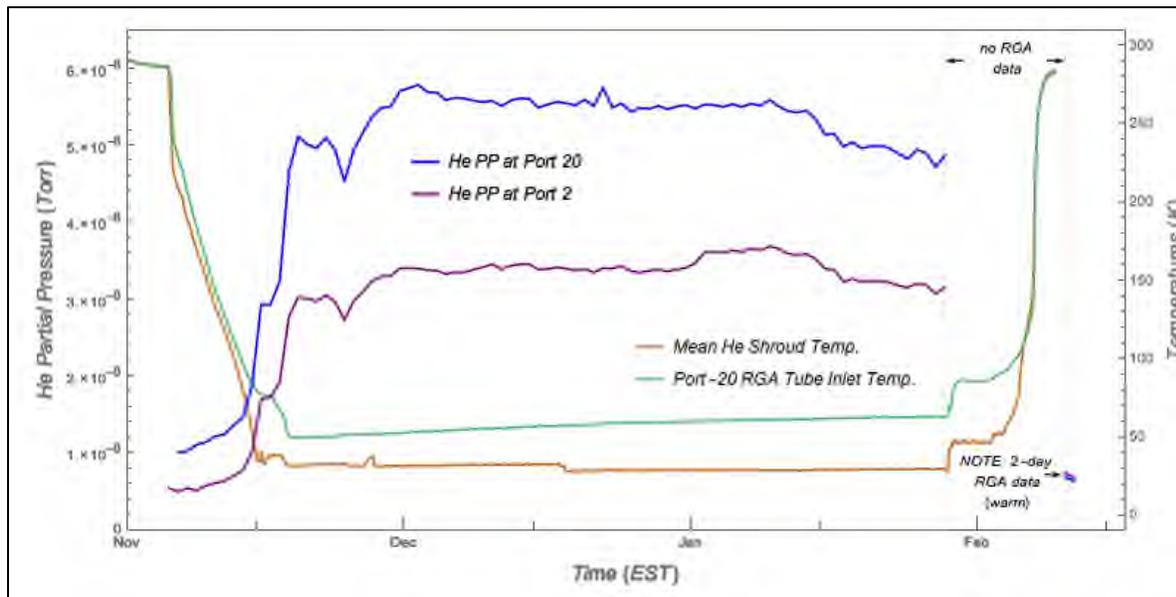
Figure 10. Average daily helium partial pressure measured at Ports 2 and 20 in relation to the mean helium shroud temperature and the inlet temperature of the Port 20 sampling tube.

Average daily helium partial pressures, covering most of the CV3 test campaign, are presented in Figure 10 and show evidence of a helium cold-leak within the helium-shroud or STMS enclosures. The inverse relationship between partial pressure and temperature may be the result of actual cold-leaks in addition to the effects of thermal transpiration on partial pressure measurements at each RGA. While it is difficult to quantify thermomolecular pressure increases over actual cold-volume values, due to the latter effect, they are presumed, from ideal theory, to be equivalent for corresponding RGA measurements. Therefore, pressure *differences* between Port 2 RGA and Port 20 RGA values are taken as physical and the result of leaks. One may wish to advance a caveat after considering warm partial pressure measurements at the beginning and end of CV3. Port 2 and Port 20 RGA values were nearly identical over the two days in February just prior to the helium skid being shut down and evacuated while the values are noticeably different for comparable conditions early in the test – comparable within cleanliness changes over months in vacuum.

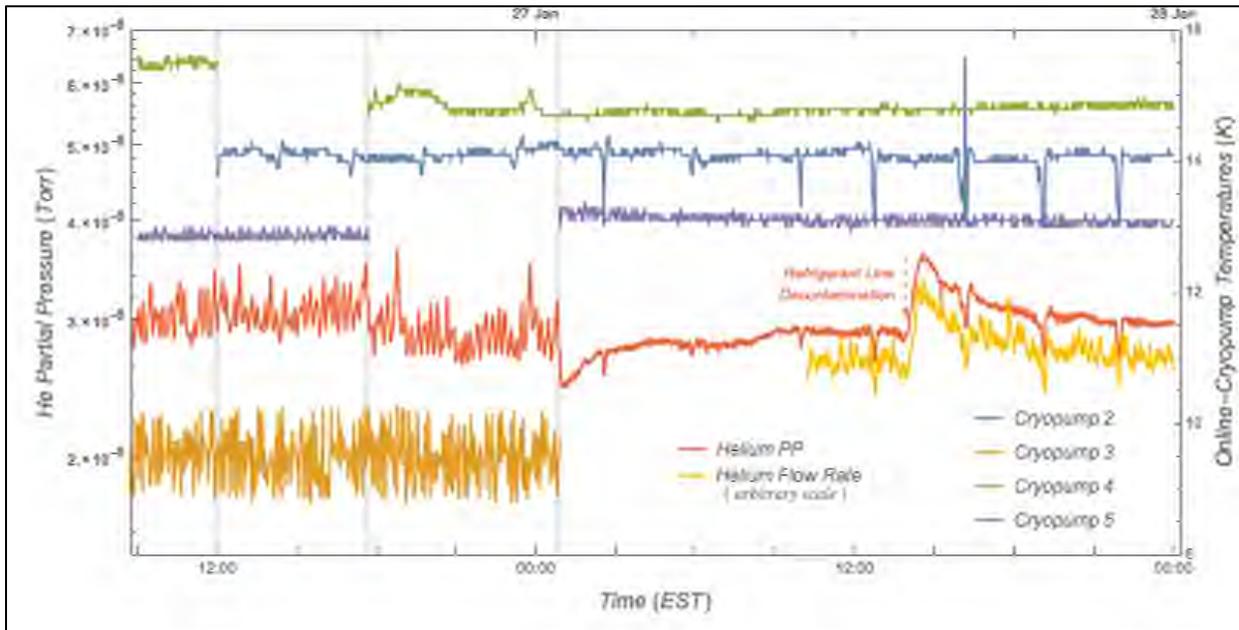
Figure 11. Plot of cryopump temperatures and Helium partial pressure during a period of various online cryopump combinations (trios) and initiation of cryocooler refrigerant line decontamination (exterior surface). Also shown is the flow rate profile from a Helium leak detector – plumbed in parallel with a mechanical pump and, together, backing the main chamber turbopump – during decontamination

Full verification of the MIRI cooler leak-rate requirement was again beyond reach in CV3. Helium partial pressure levels as seen, for example, in Figure 11 correlate to flow rates on the order of 2×10^{-4} sccs, as measured with a helium leak detector plumbed in the fore-line of the chamber turbopump. The corresponding flow rate profile, on an arbitrary scale, is also shown in Figure 11 for a period before and during decontamination of the RLDA and connected hardware. This correlation was verified through a procedure involving the rapid release of a known amount of helium, accumulated from a standard leak, into the SES chamber and observed with continuous measurements by both RGAs and the helium leak detector.

While steady-state pumping of helium is accomplished by the chamber turbopump, the chamber cryopumps can have significant effects on the partial pressure of helium. Whereas steady cooler leaks above requirements would have been obscured by the background rate, sudden changes at requirement level had the potential to be observed, as was the case during decontamination of the RLDA. That potential depended on which trio of cryopumps was on-line at any one time. Large fluctuations in partial pressure, as seen to the left in Figure XX, surely obscured changes that could be seen at more quiet times. This was clearly were not measurement noise since concurrent profiles from the two RGAs and leak detector match fluctuations perfectly, each to the other. Notice how features in the coldhead temperature profile for Cryopump 2 clearly match changes in the helium background when Cryopump 3 is off-line and are obscured when on-line. Cryopump 3 is an older $\text{\Oerlikon-Leybold COOLVAC 60k BL-V LN2}$, with dual GM refrigerators, while Cryopumps 2, 4, and 5 are newer $\text{PHPK/CVI TorrMaster TM1200}$ pumps, with single GM refrigerators. None of these features has been investigated further for causes; however, one can clearly follow the hours-long progression to helium saturation of the cryoadsorption arrays of Cryopump 5, after it was brought back on line following regeneration.

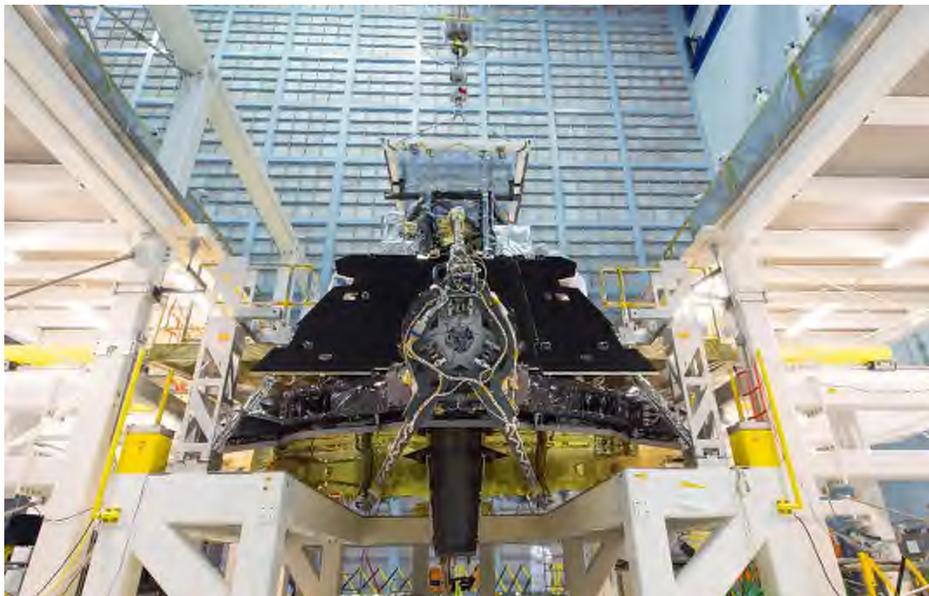
Figure 10. Fully integrated OTIS (OTE + ISIM) in the NASA GSFC Class 10,000 cleanroom

Successful completion of the JWST ISIM CV test campaign in March 2016 demonstrated that the procedures and operational capabilities of the SES are sufficient for a technically challenging program as marked by JWST ISIM-level requirements verification with all four SIs will be performed. The ISIM hardware is currently at the next level of integration with the OTE (Figure 10).
